## Warranty Guide

### Typical Failures ( guide to warranty claims )

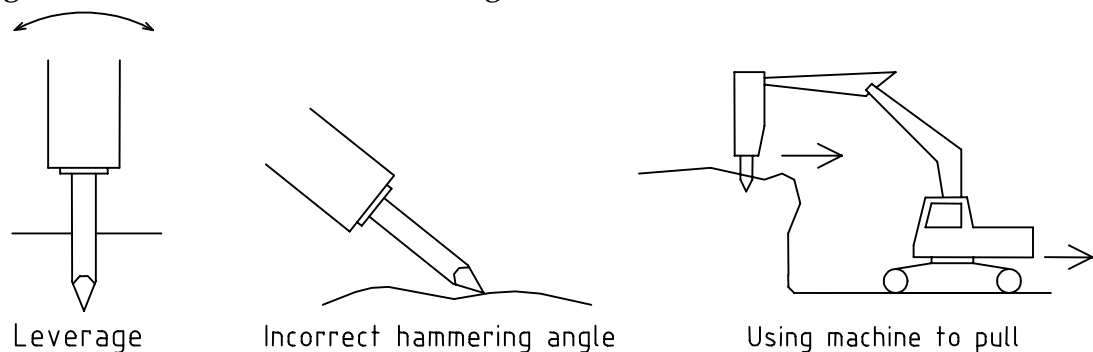
**Fig. 1**

1. The main cause of increased fatigue stress in working tool is any form of side pressure during service which creates bending the tool as a lever, using the incorrect driving angle or attempting to break ground using the pull of the machine are all detrimental to the life of a working tool and should be avoided (see Figure 1).

Remember, the hydraulic power available in the machine far exceeds the strength of a working tool if it is being used incorrectly and can "snap the tool like a carrot"

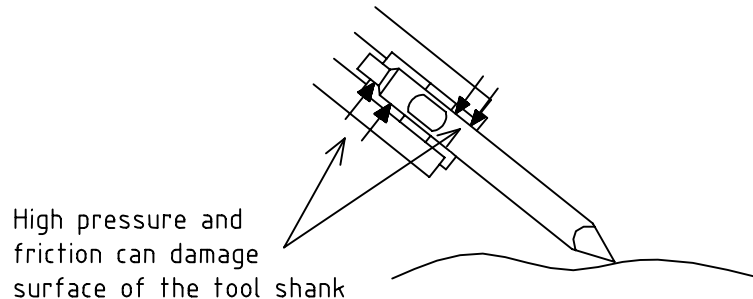
**Fig. 2**

Any form of damage to the surface of a working tool renders it more liable to suffer fatigue failure. Thus all care must be exercised to prevent accidental gouging, or contact welding ('galling' or 'pick up') due to contact between the tool and the bushings through the lack of lubrication or excessive bending ( see Figure 2 )

Care must be taken to avoid metal to metal contact that, as a result of galling or pick-up, could cause deep damage marks which, in turn, lead to the formation of fatigue cracks and eventual failure of the working tool. Ensure that the shank of the working tool is well lubricated before locating in the machine. Molybdenum bisulphide grease is recommended for this application at three hourly intervals or as per manufacturers instructions.

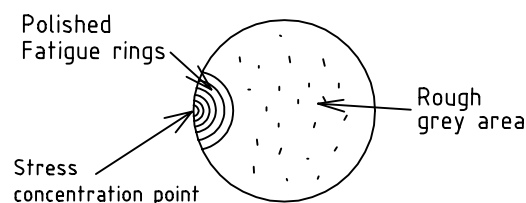
**Fig. 4**

The fracture face itself will normally exhibit a semi circular polished area with the remainder being of a rougher appearance ( see Figure 4 ).

The polished semi-circular area in Figure 4 is the fatigue area and generally starts from a damage mark or other stress raiser on the outside of the working tool and spreads inwards. The fatigue area slowly widens until the stresses being applied to the working tool cause sudden failure of the remaining section.

Generally, the size of the fatigue area indicates the level of stress applied to the tool, i.e. the smaller the fatigue area, the higher the stress level, although it must be borne in mind that

once initiation of a fatigue crack has taken place, it requires a lower stress level to cause it to grow.

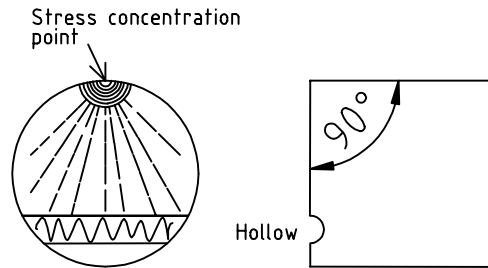
**Fig. 6**

Fig. 6. Typical of high stress fracture, usually caused by using the machine to 'pull'. Warranty claims rejected.

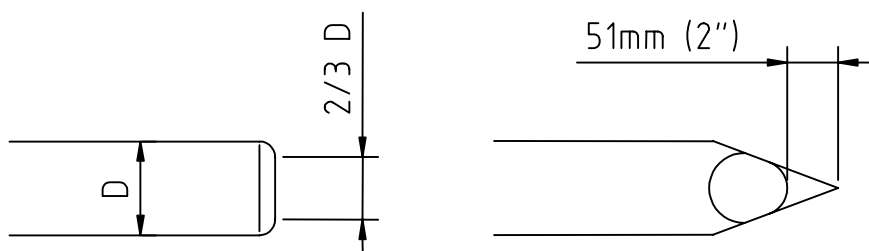
**Fig. 8**

Fig. 8. Blunt tools worn more than 1/3 diameter ormoil points and chisels worn back more than 51 mm (2") of working end classed as reasonable life. Warranty claims rejected.
